PROJECT | Guildford

PRODUCT(S) | CORE Drainage Cells, CORE Drive

Fin Drainage & Gravel Driveway

PROJECT | **SOLVE DAMP ISSUE ON HOUSE AND**
 BRIEF | **PROVIDE A WELL DRAINED DRIVE**

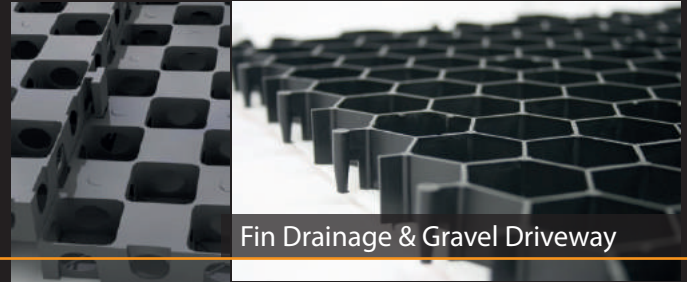
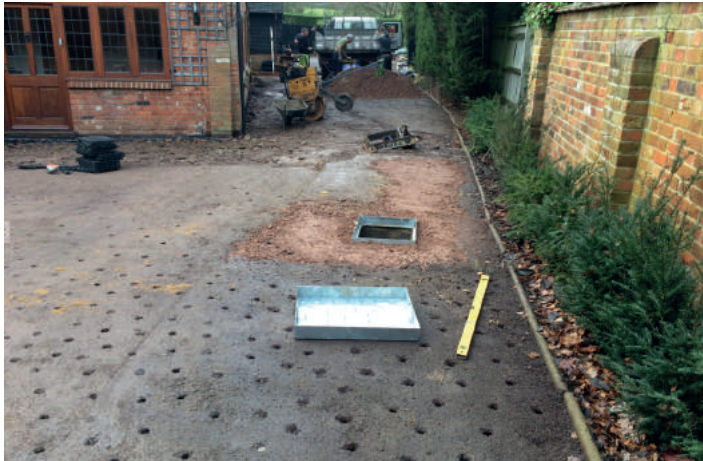
A trench was excavated alongside the wall and adjacent driveway. The trench was lined with heavy gauge Damp proof membrane. CORE drainage cells were wrapped in core... geotextile membrane and placed vertically within the trench leading to the existing rainwater downpipe a connection was made to allow both the downpipe and drainage cells to use the existing drainage system, the as dug material was put back into the ground and re compacted. Drainage holes were punctured into the macadam and covered with a core.... Non woven geotextile membrane to protect them. Coredrive 38-25R was laid over a sharp sand blinding and filled with a locally sourced 10/12mm angular gravel
