PROJECT | Guildford

PRODUCT(S) | CORE Drainage Cells, CORE DRIVE 28-35R

#### PROJECT | SOLVE DAMP ISSUE ON HOUSE AND BRIEF | PROVIDE A WELL DRAINED DRIVE

#### PRACTICAL SOLUTION | INSERT LINEAR DRAINAGE AGAINST HOUSE, CREATE DRAINAGE HOLES IN EXISTING DRIVE

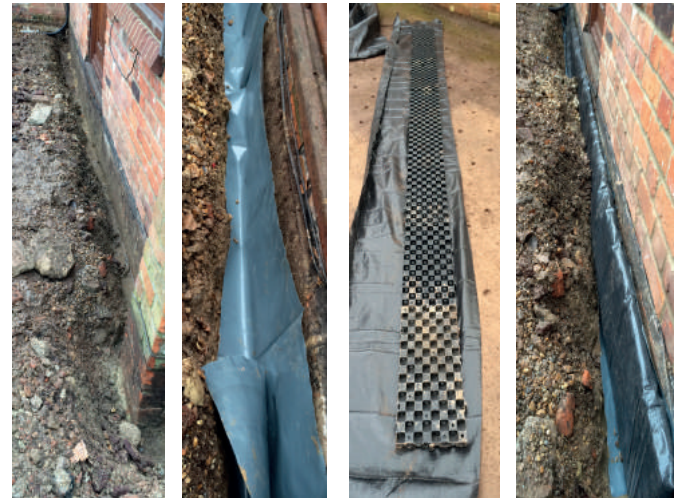
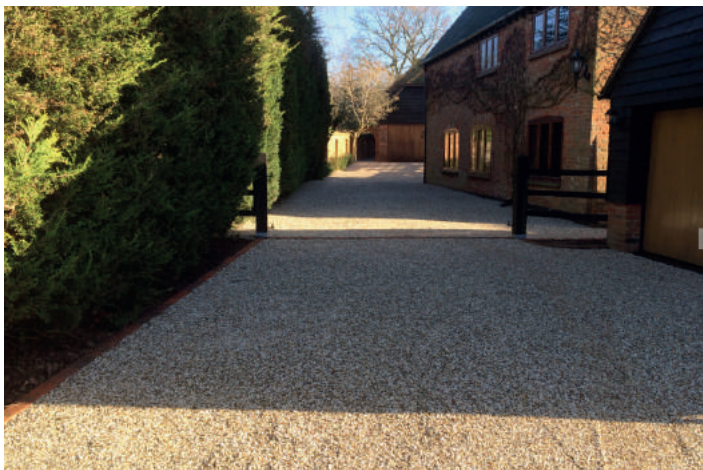
A trench was excavated alongside the wall and adjacent driveway. The trench was then lined with heavy gauge damp proof membrane. CORE drainage cells were wrapped in CORE geotextile membrane and placed vertically within the trench leading to the existing rainwater downpipe. A connection was made to allow both the downpipe and drainage cells to use the existing drainage system, the dug material was put back into the ground and re compacted. Drainage holes were punctured into the macadam and covered with a CORE Non woven geotextile membrane to protect them. CORE Drive 38-25R was laid over a sharp sand blinding and filled with a locally sourced 10/12mm angular gravel

Using a gravel stabilisation grid meant the existing surface could be utilized as part of the sub base, producing a significant cost saving and improving the environmental impact of the works. The porous surface allows water to flow through, avoiding surface water build up which maintains a clean surface for pedestrians. Also perfectly suitable for access by prams, pushchairs and DDA compliant if disabled access were required. The vertical cells have an immense flow rate allowing them to deal with surface and sub surface water relieving the hydrostatic pressure from the waterlogged ground immediately adjacent to the building. The surface is now flat, firm and puddle free. The house no longer has damp issues.
